Navajo Abandoned Uranium Mine

Site Screen Report

Mine Name: C-3
Mine ID: 516

Weston Solutions, Inc.

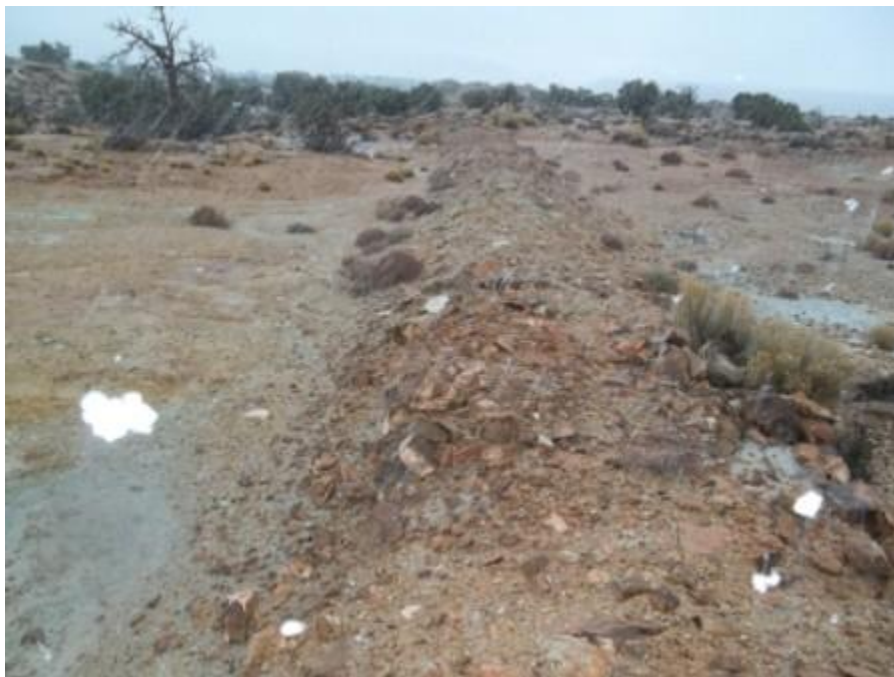
Photo 7

Mine Site #516 - Berm

Erosional berm above the site

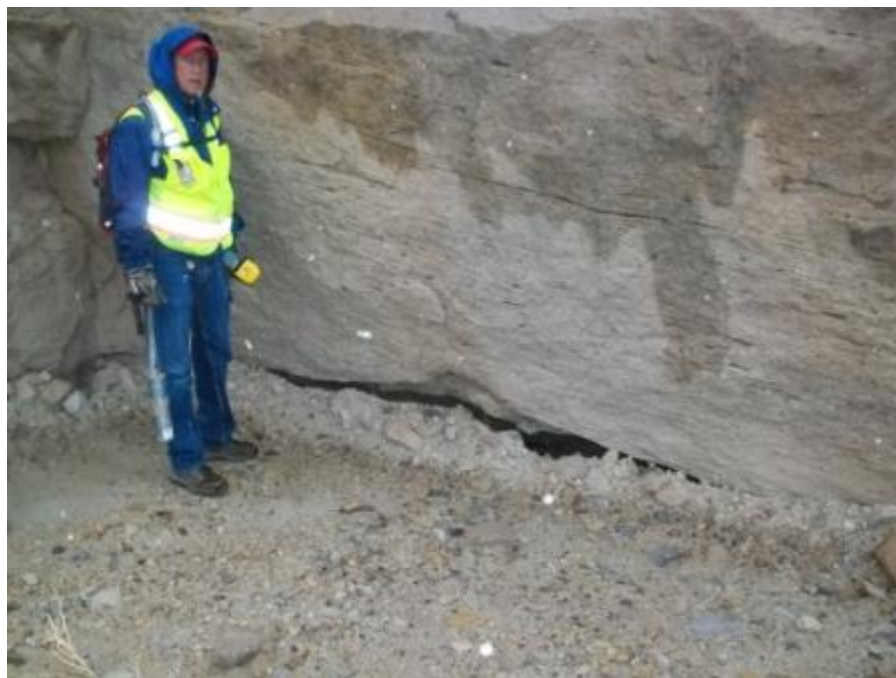
Photo 10

Mine Site #516 - Adit

2 possible adits - voids along top of the waste rock, pushed against the ledge

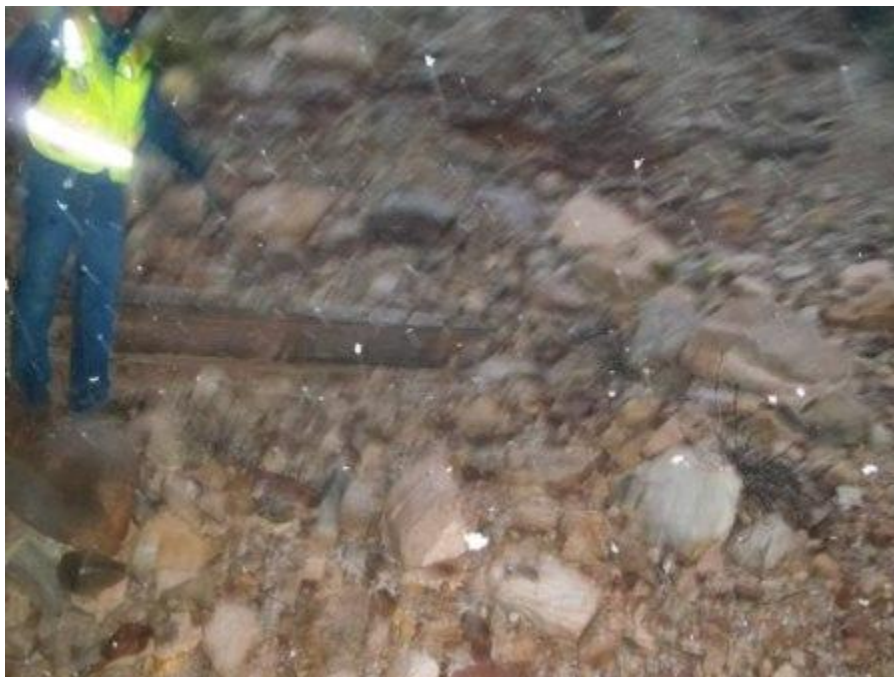
Photo 11

Mine Site #516 - Adit
